TRANSPORTATION RESEARCH CENTER

ON-SITE AIR BAG INVESTIGATION

CASE NO. - 95-21
FLEET - LEASED VEHICLE
LOCATION - WISCONSIN
ACCIDENT DATE - 1995

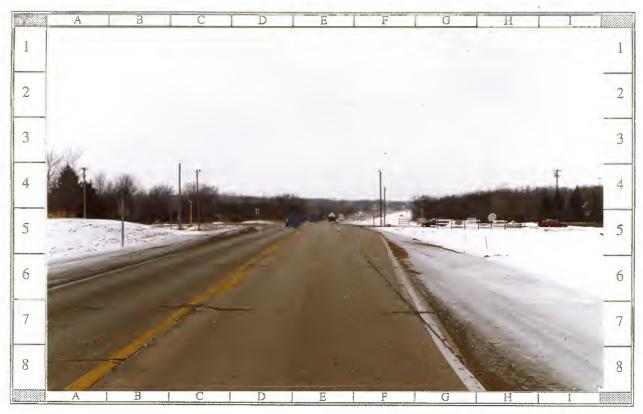
01 -- Case Vehicle's northward travel path in northbound lane approximately 50 meters (164 feet) south of impact

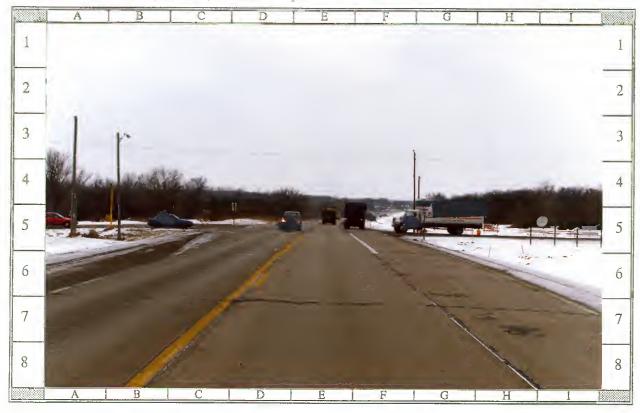
02 -- Case vehicle's northward travel path in northbound lane approximately 30 meters (98 feet) south of impact

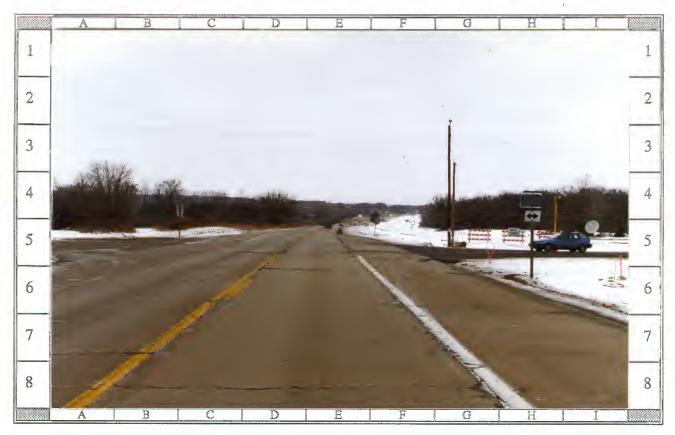
03 -- Case Vehicle's northward travel path in northbound lane approximately 20 meters (66 feet) south of impact

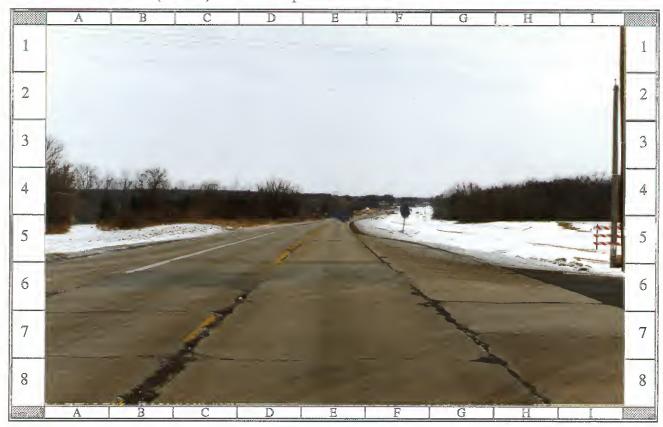
04 -- Case Vehicle's northward travel path in northbound lane approximately 5 meters (16 feet) south of impact

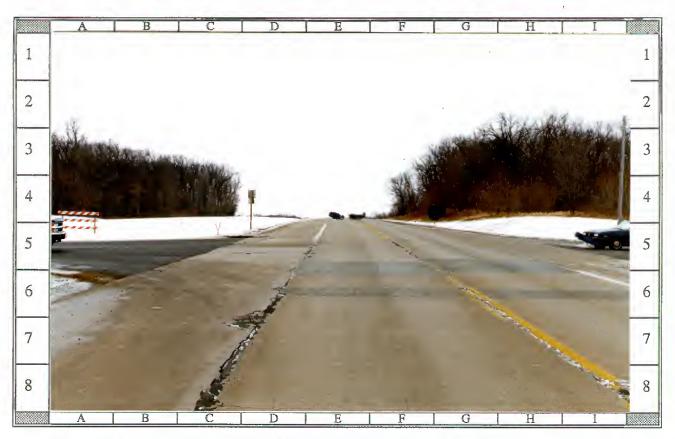
05 -- Southward view of Case Vehicle's northward travel path in the northbound lane, north of impact area in intersection

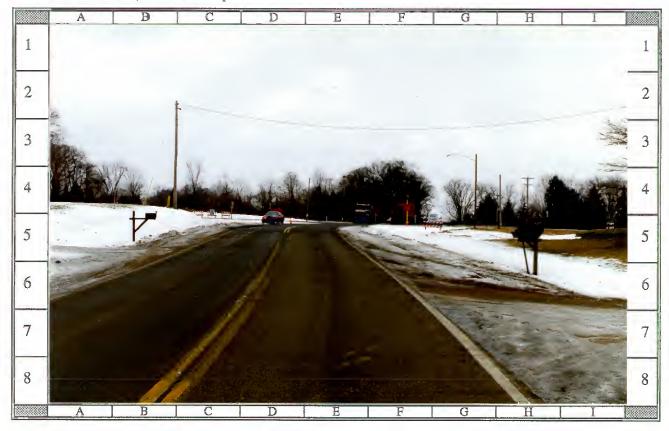
06 -- Vehicle #2's westward travel path in westbound lane approximately 50 meters (164 feet) east of impact

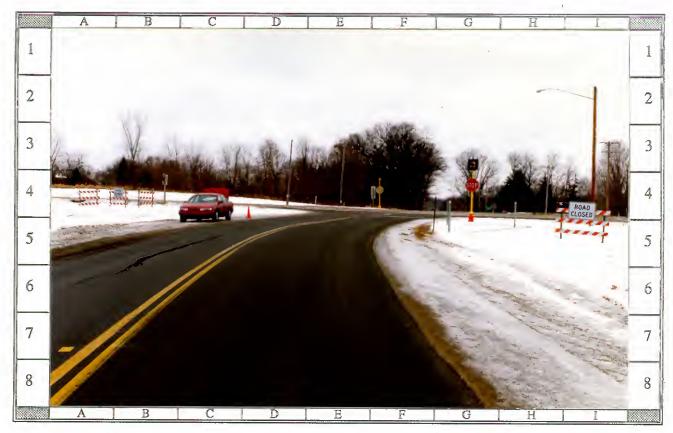
07 -- Vehicle #2's westward travel path in westbound lane approximately 30 meters (98 feet) east of impact

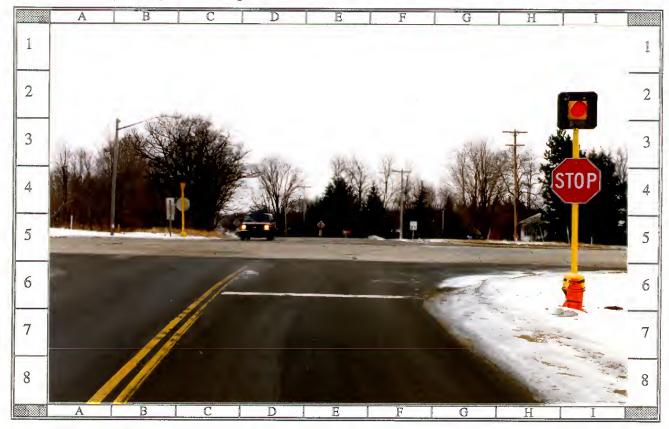
08 -- Vehicle #2's westward travel path in westbound lane approximately 20 meters (66 feet) east of impact

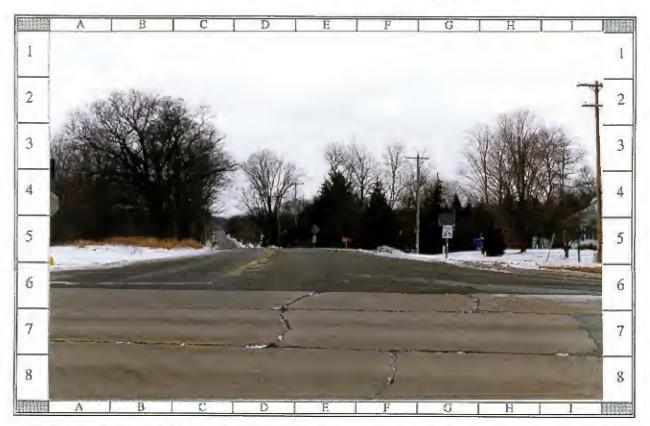
09 -- Vehicle #2's westward travel path in westbound lane approximately 5 meters (16 feet) east of impact

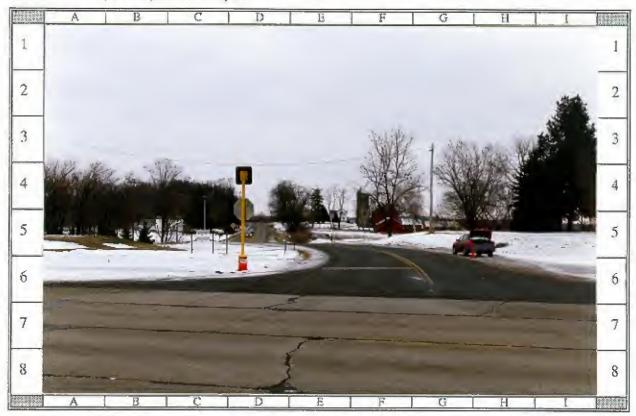
10 -- Eastward view of Vehicle #2's westward travel path in the westbound lane, west of impact area in intersection

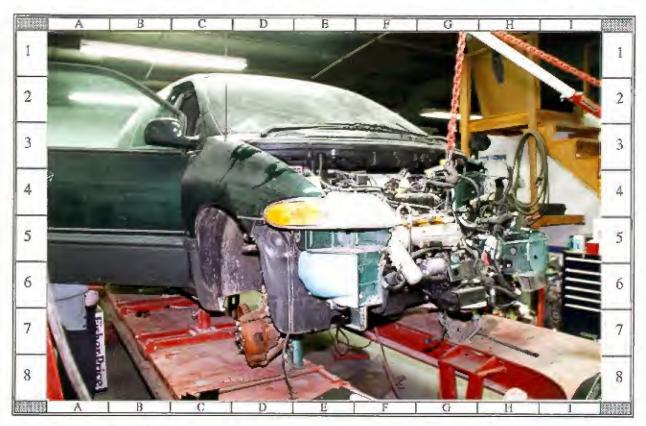
11 -- Case Vehicle's damaged front viewed from 30 degrees right of front; NOTE: vehicle in process of being repaired

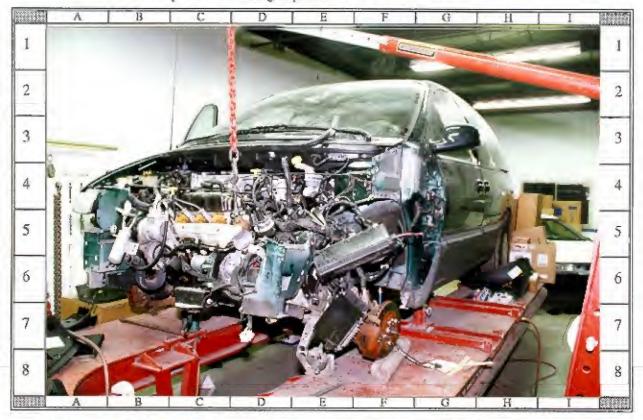
12 -- Case Vehicle's damaged front viewed from 30 degrees left of front; NOTE: damage primarily to front left corner

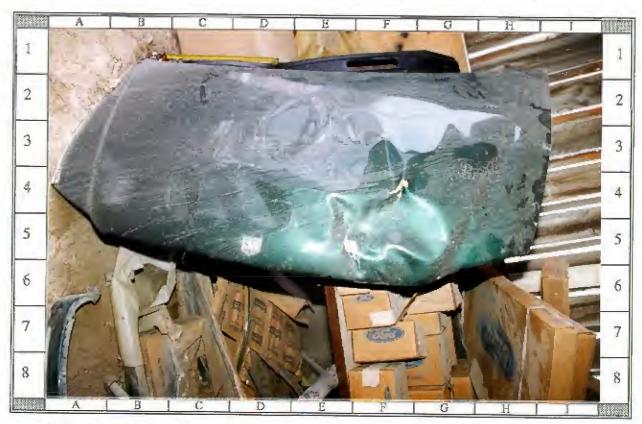
13 -- Damage to Case vehicle's removed hood viewed from front showing that direct damage is primarily to left half; NOTE: photo is sideways

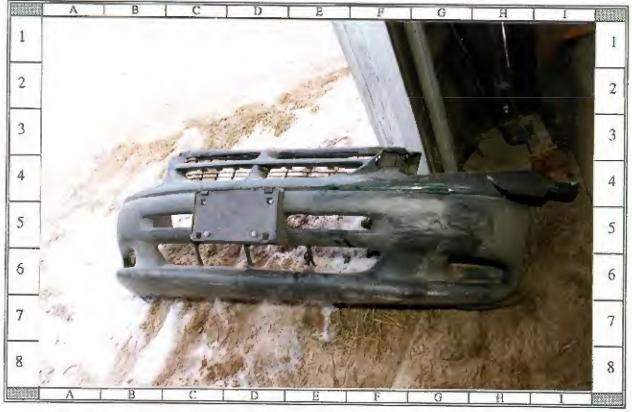
14 -- Damage to Case Vehicle's removed front bumper from left; NOTE: direct damage starts at left corner and goes three-fourths of the way to right corner

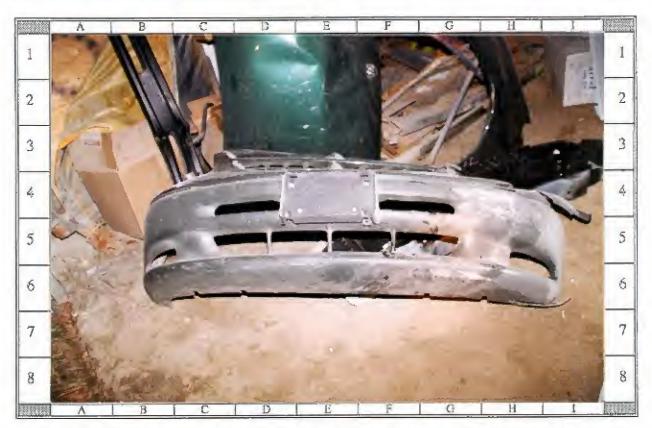
15 -- Damage to Case Vehicle's removed front bumper from center showing primary area of direct damage to left half of bumper (cells D4--H6)

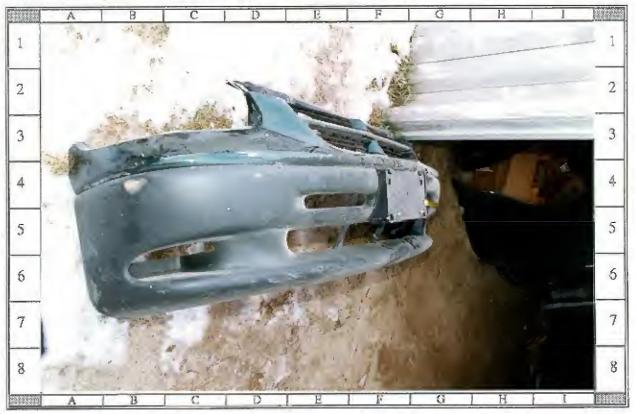
16 -- Damage to Case Vehicle's removed front bumper from right showing that right bumper corner has no direct damage; NOTE: photo is sideways

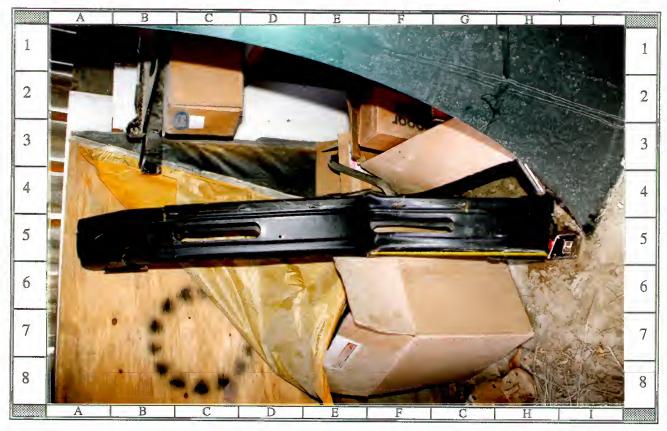
17 -- Case Vehicle's removed bumper reinforcement bar showing that direct damage is primarily to left half (cells D4--H5); NOTE: photo is sideways

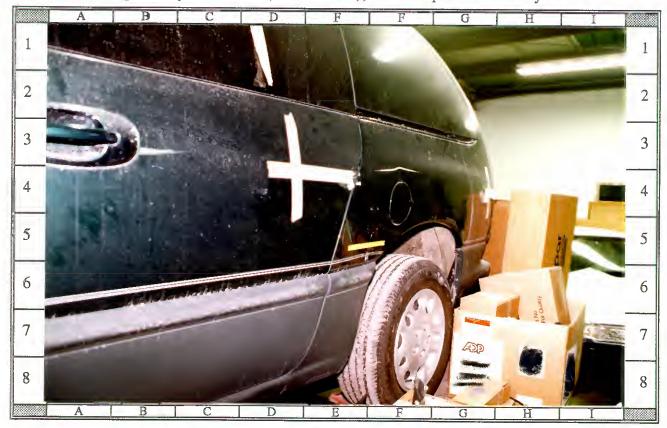
18 -- Case Vehicle's damaged left quarter panel from left front showing minimal sideslap crush from impact with Vehicle #2's left front bumper corner

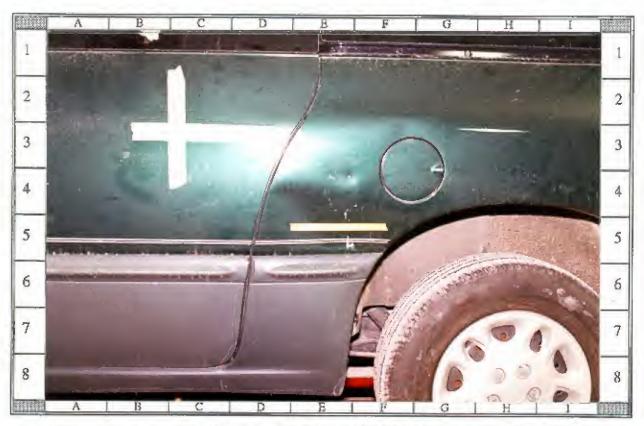
19 -- Close-up of sideslap damage to Case Vehicle's left quarter panel from left; NOTE: white cross represents body shops markings

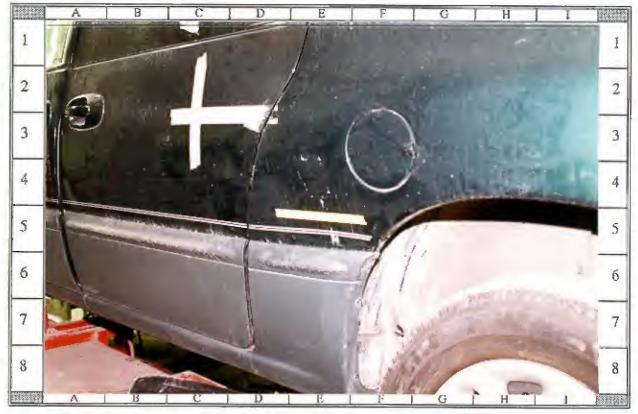
20 -- Case Vehicle's damaged left quarter panel from left rear

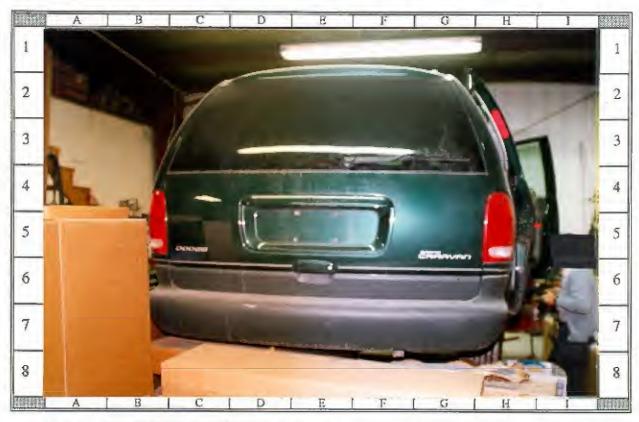
21 -- Case Vehicle's undamaged back plane

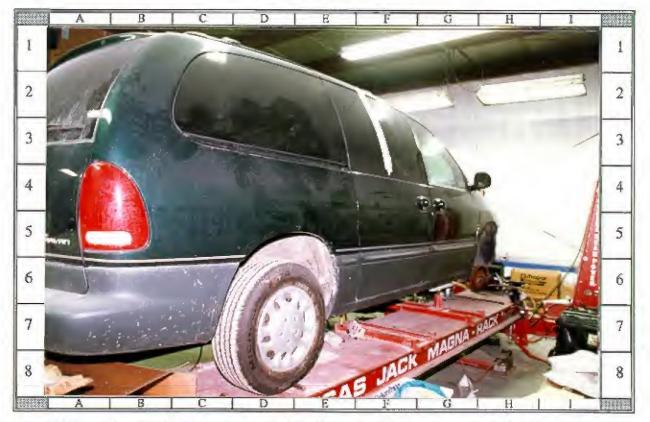
22 -- Case Vehicle's undamaged right side viewed from approximately 45 degrees right of back

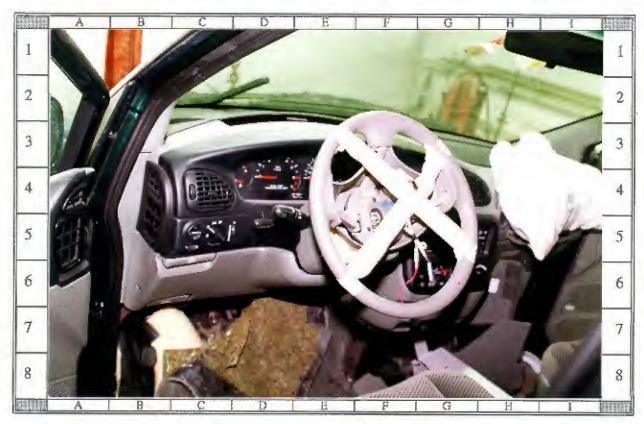
23 -- Case Vehicle's driver seating area viewed from left showing dash, steering wheel, and removed air bag module; NOTE: deployed right front air bag

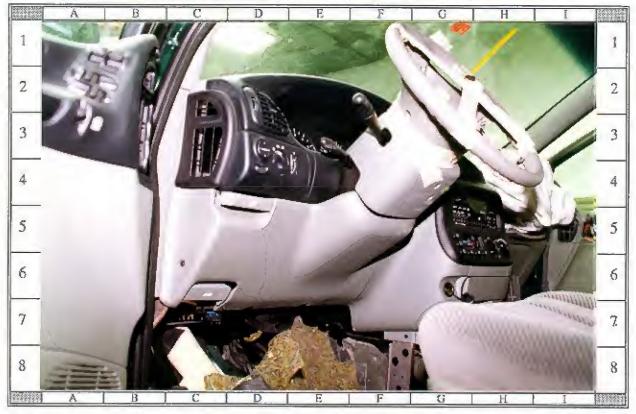
24 -- Case Vehicle's noncontacted dash and knee bolster; NOTE: contact (green dot) to right underside of steering column (cell G4)

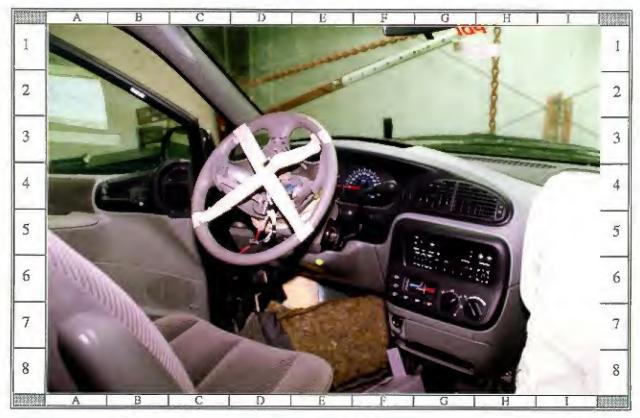
25 -- Case Vehicle's driver seating area, steering column, left and center dash and center console viewed from right rear; NOTE: removed driver's air bag

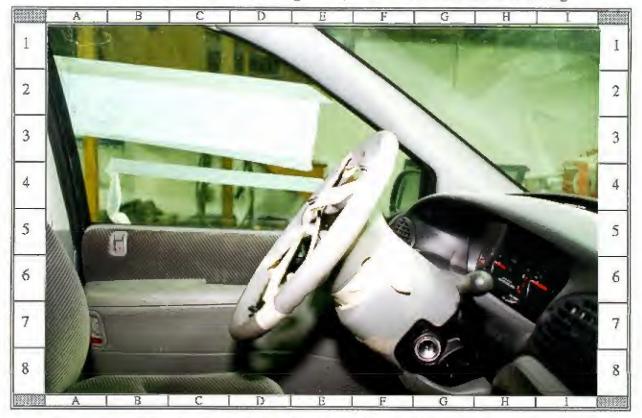
26 -- Case Vehicle's undeformed steering wheel rim; NOTE: no evidence of contact to driver's door or A-pillar

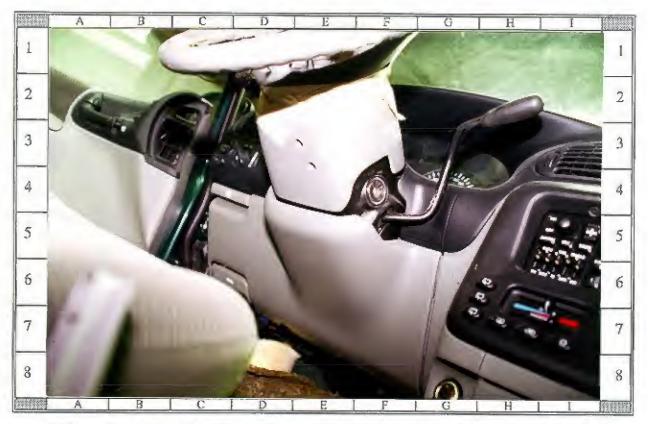
27 -- Case Vehicle's contacted (green dot) driver steering column and noncontacted knee bolster, transmission selector lever, and center console

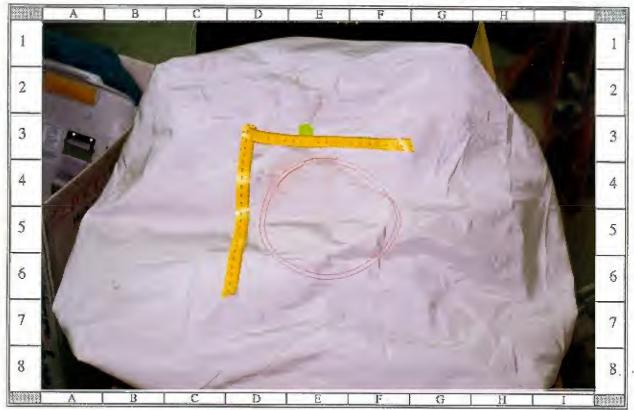
28 -- Case Vehicle's removed driver air bag with makeup transfer from driver below and to the right of yellow tape (cells D4-E4)

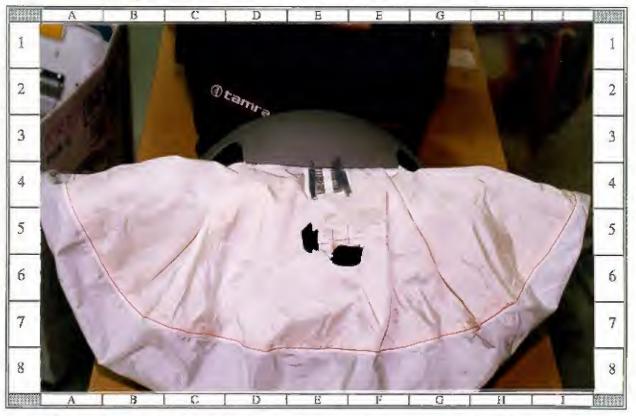
Case Vehicle's removed driver air bag and top cover flap; NOTE: no evidence of contact found

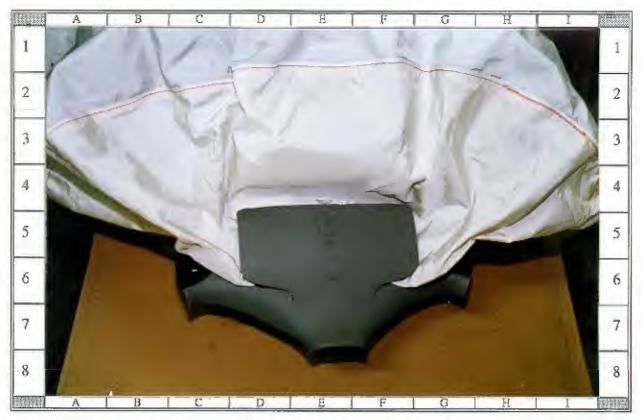
Backside of Case Vehicle's removed driver air bag and bottom cover flap; NOTE: no evidence of contact found

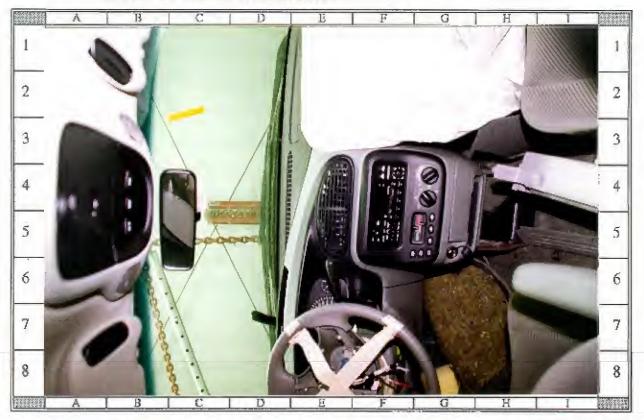
Case Vehicle's center dash and console area, windshield, rear view mirror, and roof console; NOTE: contact evidence to windshield

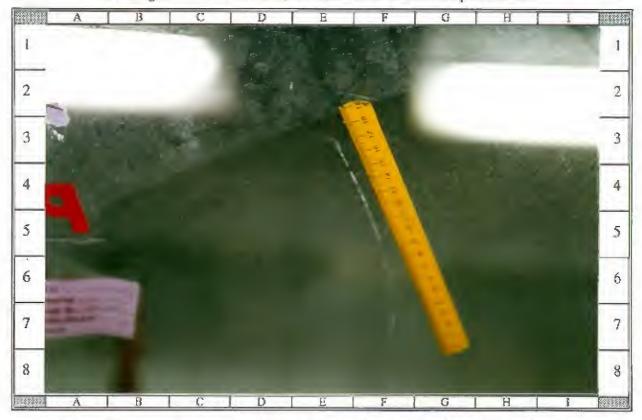
The interior inspection also revealed a scratch to the inside of the windshield which most likely was caused when the broken plastic piece from the child seat's struck it. In addition, a powdery scuff on the lower right, backside corner of the rearview mirror was found which this investigator believes most likely was caused by the deploying right front air bag. An inspection of the right front air bag showed no contacts other than a scuff to the lower half of the bag which most likely occurred during deployment from contacting the bottom air bag cover flap (facia plate).

The momentum from the initial crash followed by the subsequent sideslap most likely caused the broken piece of plastic to contact the windshield. The windshield scratch (contact) appears to have a plastic compound base to it. His movement during the sideslap event was most likely very minimal because of the sideslapping nature of the impact.

34 -- Close-up of contact (scratch mark) to right windshield most likely from broken piece of child seat; see photograph #52

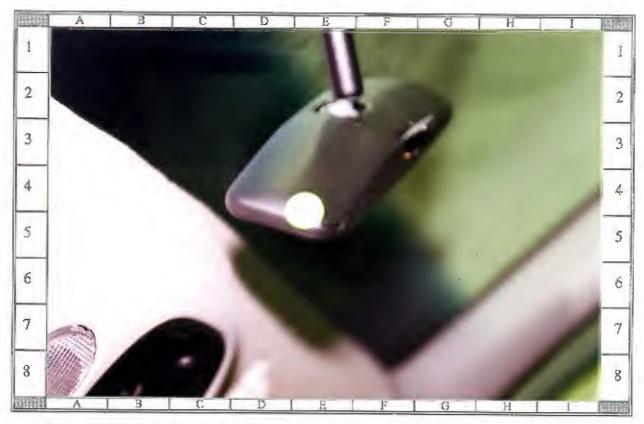
35 -- Close-up of contact to back right corner of Case Vehicle's rearview mirror most likely from right front air bag; NOTE: roof console in background

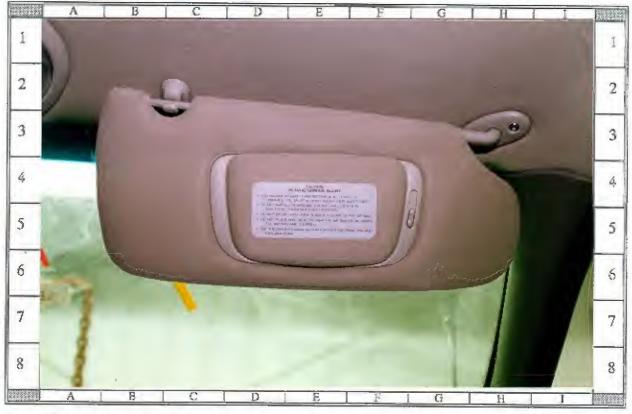
36 -- Case Vehicle's warning statement located on underside of right front sunvisor; statement warns against use of rear facing child seats at this position

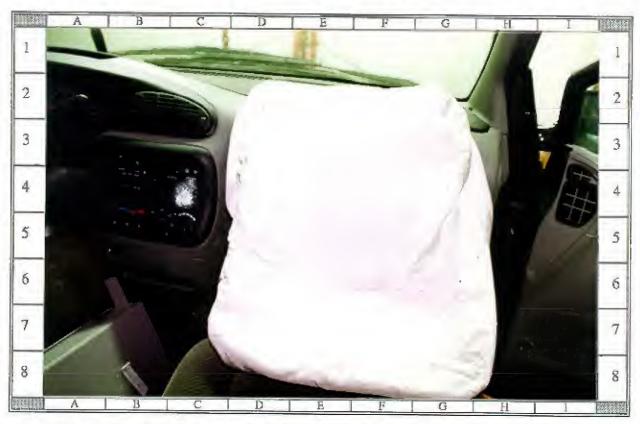
37 -- Case Vehicle's right front seating area and center console showing deployed right front air bag; NOTE: no evidence of contact found

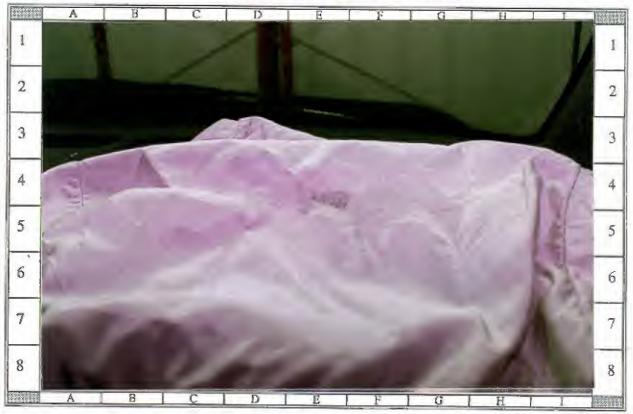
38 -- Close-up of Case Vehicle's deployed right front air bag showing black scuff (cell E4) which most likely came from bottom cover flap during deployment

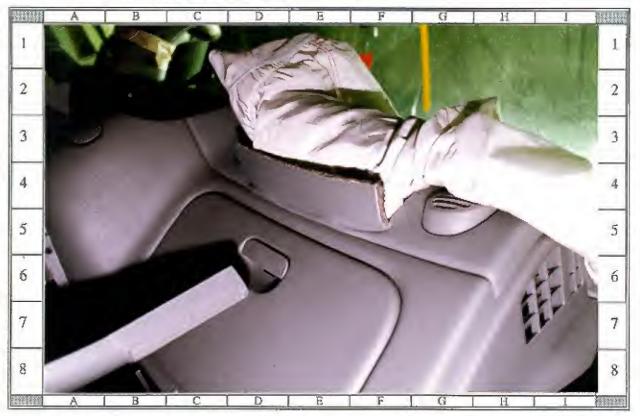
40 -- Case Vehicle's glovebox and bottom cover flap from right front air bag; NOTE: no evidence of contact found

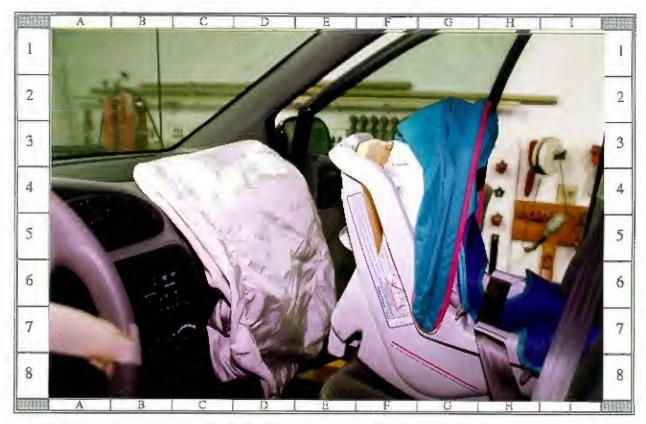
41 -- Case Vehicle's front right seating area with child seat in original position showing close proximity to deployed right front air bag from left

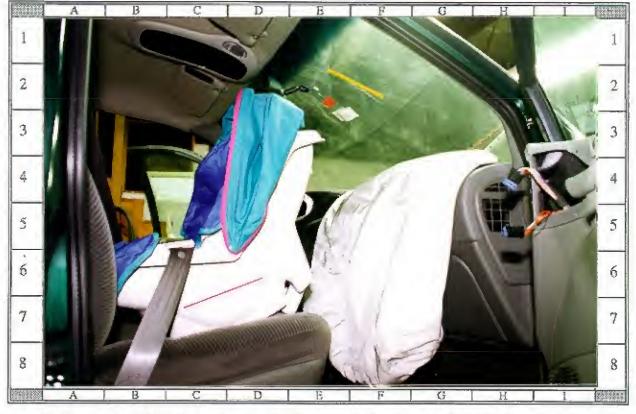
42 -- Case Vehicle's front right seating area with child seat in original position showing close proximity of deployed right front air bag from right

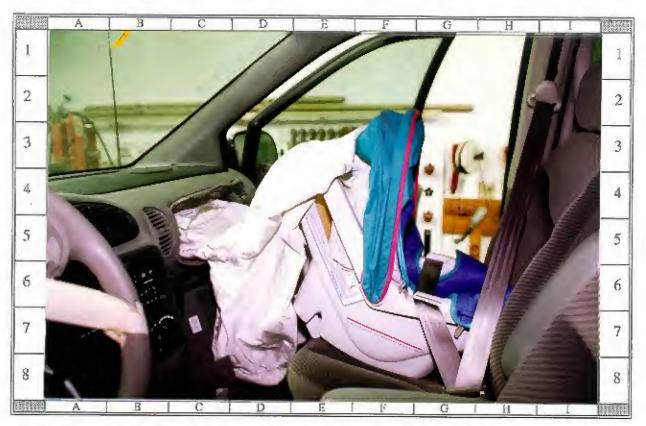
At impact the infant boy most likely slid forward some slight distance but was held in place by the infant seat's harness and shield, which according to the driver were worn properly, as well as vehicle's safety belts. The deploying air bag impacted the back of the infant seat causing the child seat to crack and a piece of its right rear corner to brake off. An inspection of the infant child seat revealed a large crack along with a broken-off piece of plastic approximately 15 centimeters (6 inches) in length broken off the right rear corner near the right shoulder of the infant who was laying in place, facing rearward. According to the driver (grandmother), during the crash the infant cried out most likely when the deploying air bag struck the child's infant seat from behind. It should be noted that the distance from the back top portion of the infant, child seat to the front of the air bag module was 29 centimeters (11.4 inches).

43 -- Case Vehicle's right front seating area showing deployed air bag extended rearward onto child seat from left; NOTE: broken child seat (cell E4--E5)

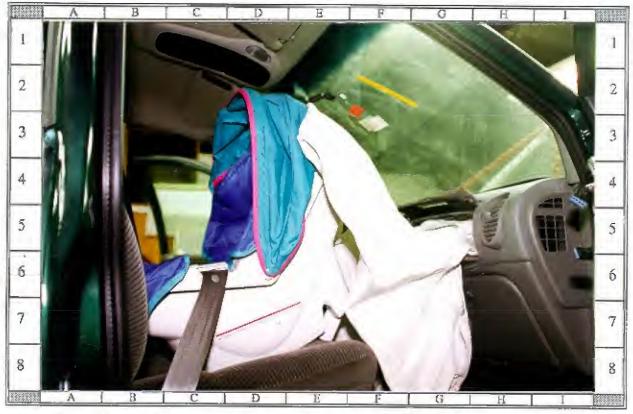
44 -- Case Vehicle's front right seating area showing deployed air bag extended rearward onto child seat viewed from outside right front door

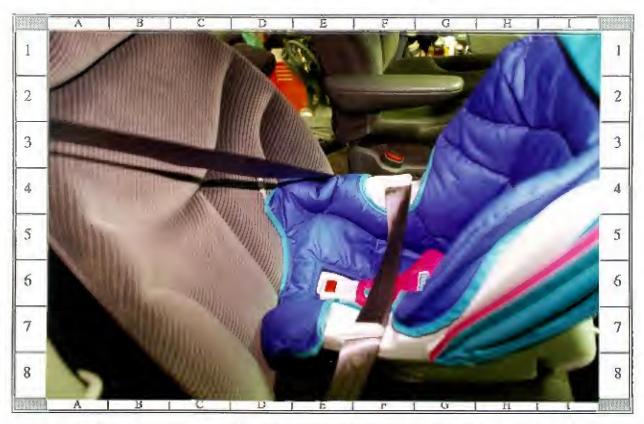
45: Overhead right view of Case Vehicle's child seat in it's original position with 3-point belt buckled; NOTE: child seat equipped with harness and shield

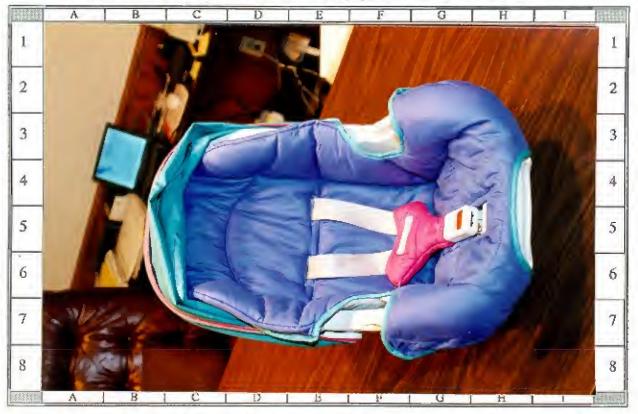
45: Frontal view of Case Vehicle's removed Fisher-Price child safety seat used in crash; NOTE: seat equipped with harness and shield

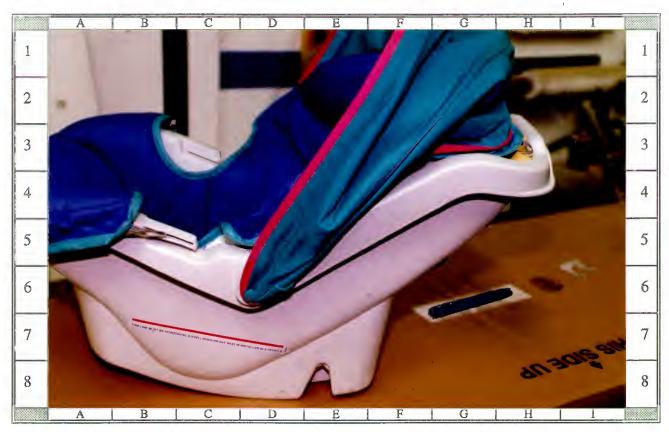
47: Undamaged left side of Case Vehicle's removed Fisher-Price child safety seat used in crash; NOTE: during crash this side was next to right front door

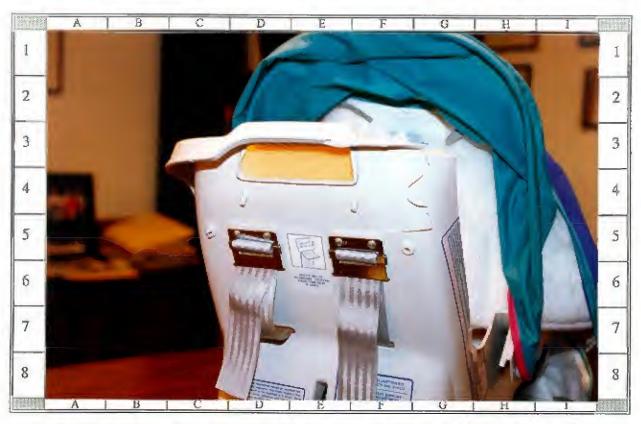
49: Rear right view of cracked and broken area of Case Vehicle's removed Fisher-Price child safety seat used by right front occupant in crash

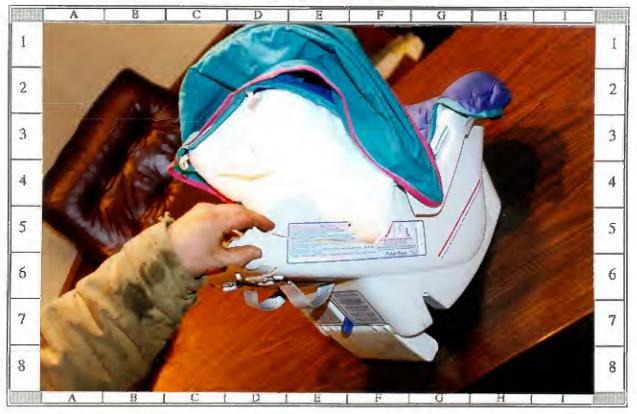
50: Case Vehicle's removed Fisher-Price child safety seat showing a broken piece of seat held near it's original place viewed from ~ 45 degrees right of rear

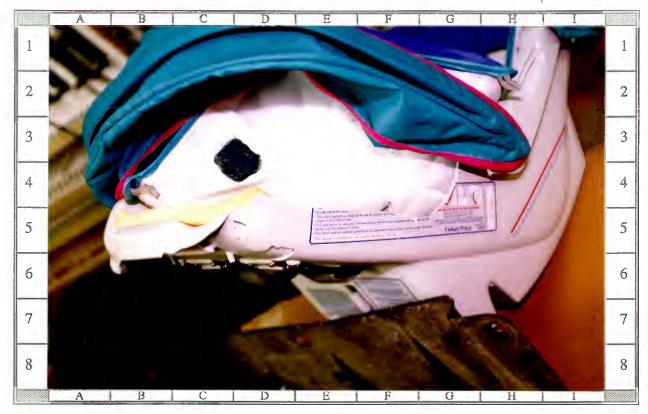
51: Right overhead view of broken and cracked area on Case Vehicle's removed Fisher-Price child safety seat used in crash by right front occupant

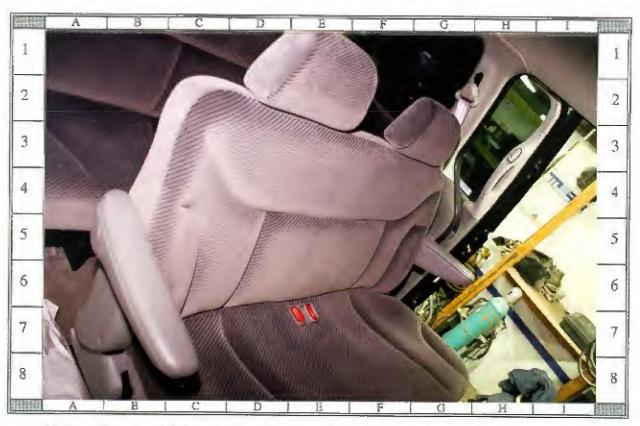
53 -- Case Vehicle's second seating area; NOTE: adjustable head restraints and shoulder belt anchorage (on C-pillar) and open left rear door

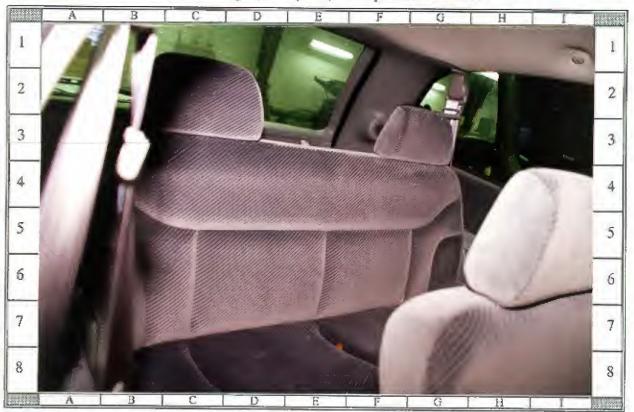
54 -- Case Vehicle's third seating area; NOTE: adjustable head restraints and available three-point seatbelts at outboard positions

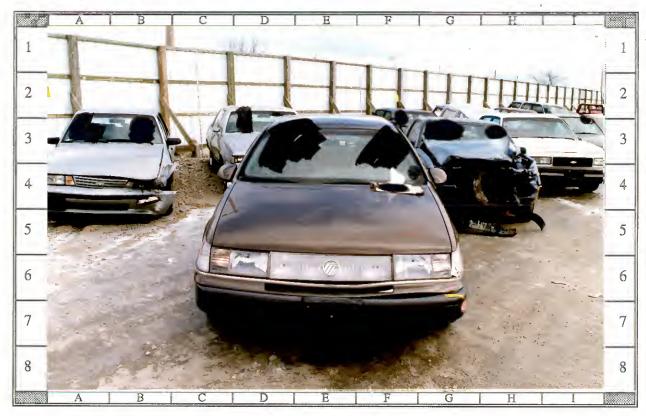
55 -- Frontal view of Vehicle #2 showing induced damage to grille, left front bumper corner, and left headlight (yellow tape area)

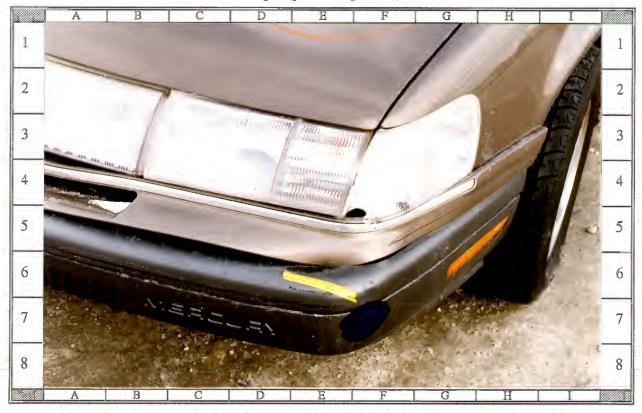
56 -- Front left close-up of Vehicle #2's direct and induced damage to left front bumper corner and headlight area which occurred during sideslap (2nd event)

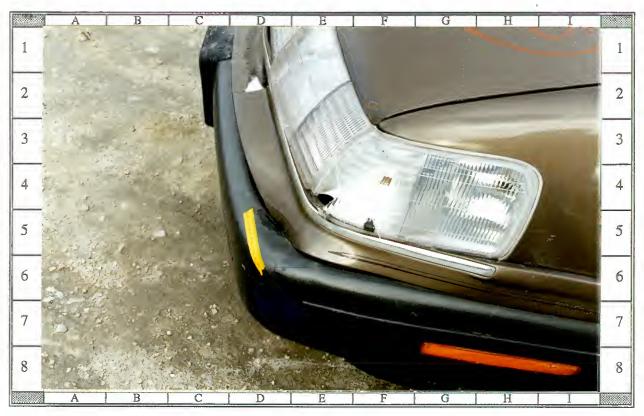
57 -- Close-up from left of Vehicle #2's direct and induced damage to left front bumper corner and headlight area which occurred during sideslap (2nd event)

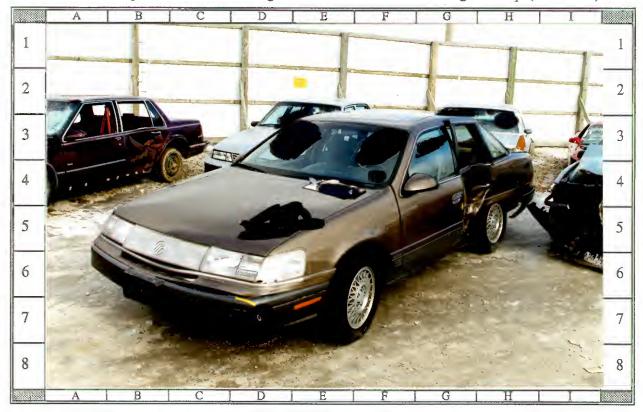
58 - Vehicle #2 viewed from ~45 degrees left of front showing sideslap damage to left front bumper corner and initial contact damage to left rear

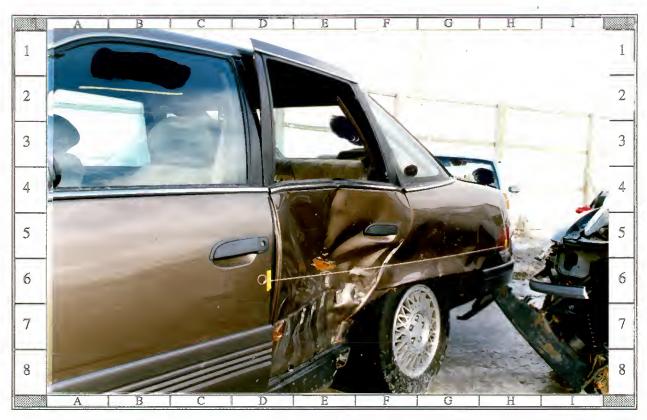
59 - Vehicle #2's left side damage viewed from ~30 degrees left of front showing direct and induced damage to left rear door and left quarter panel

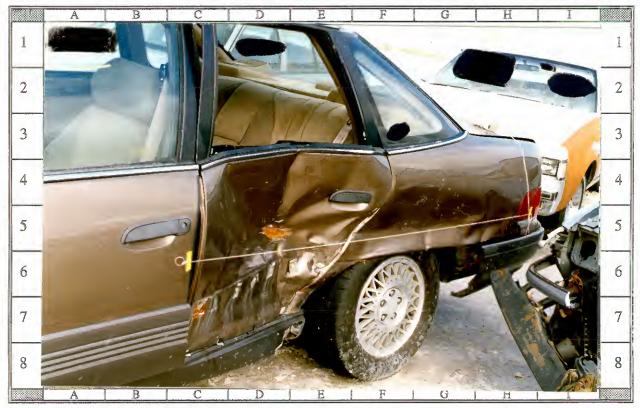
60 -- Vehicle #2's left side damage viewed from ~45 degrees left of front showing direct and induced damage to left rear door and left quarter panel

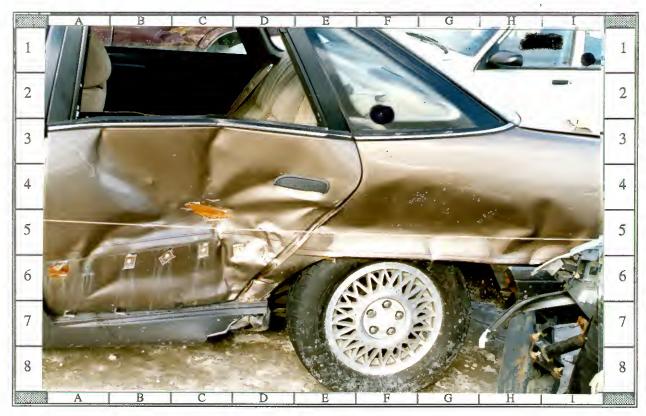
61 -- Vehicle #2's direct left side damage viewed from left showing damage to left rear door and quarter panel; NOTE: disintegrated left rear window

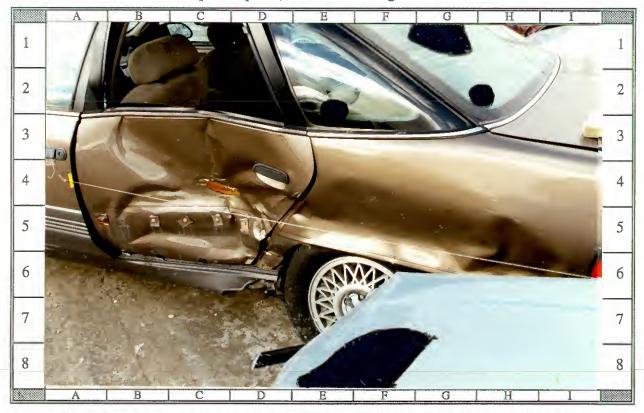
62 -- Vehicle #2's direct left side damage viewed from ~ 60 degrees left of back showing damage to left rear door and left quarter panel

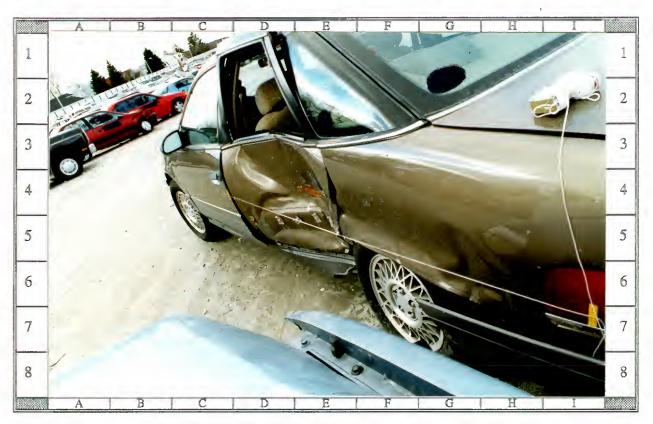
63 -- Vehicle #2's left side damage viewed from ~20 degrees left of back showing direct and induced damage to left rear door and left quarter panel

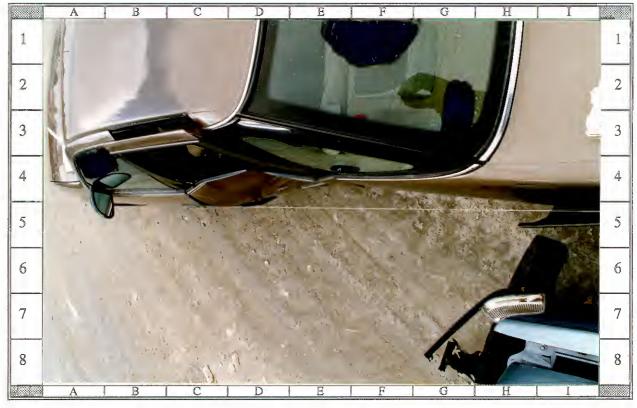
64 -- Overhead back reference line view of Vehicle #2's left side damage; NOTE: intrusion through left rear passenger door

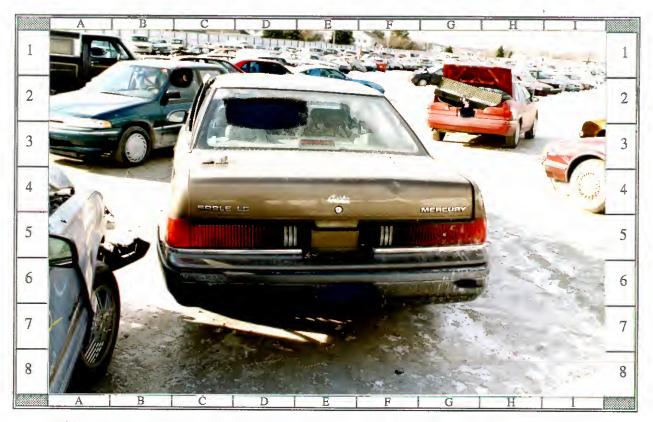
65 -- Vehicle #2's back plane showing minor induced damage to left rear bumper corner and trunk lid

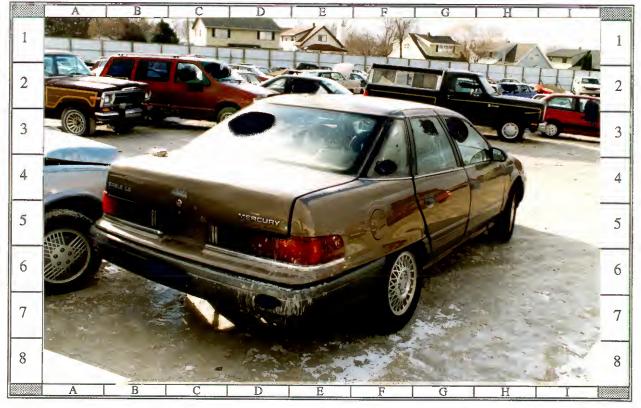
66 -- Vehicle #2's back and right sides viewed from ~30 degrees right of back showing induced damage to trunk lid and undamaged right side

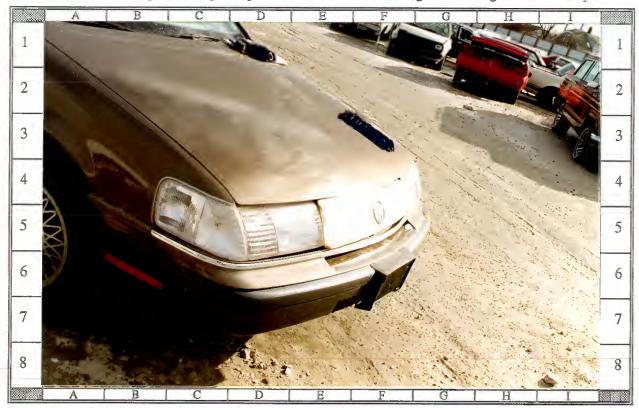
68 -- Vehicle #2's frontal damage viewed from ~75 degrees right of front showing induced damage to center of grille (cells E5--F5)

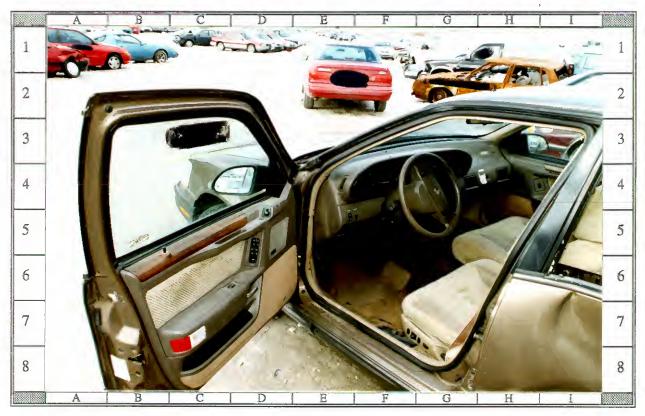
69 -- Vehicle #2's driver seating area showing interior door surface, steering wheel, and dash; NOTE: no evidence of contact to door surface, wheel, or dash

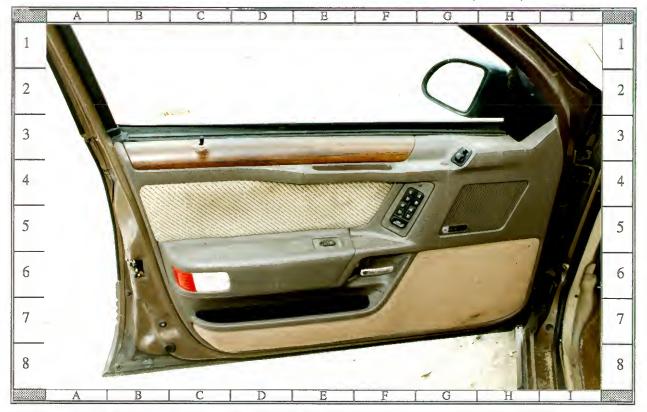
70 -- Close-up of interior surface of Vehicle #2's driver door showing no evidence of contact

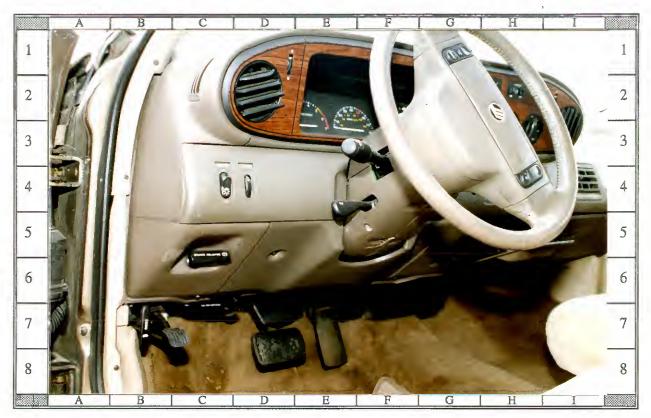
71 -- Close-up of Vehicle #2's steering wheel and column, instrument panel, and left lower dash showing no contact evidence

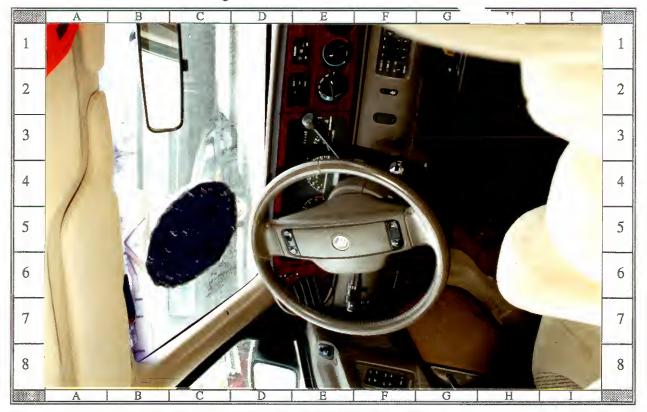
72 -- Vehicle #2's driver seating area viewed from rear center position showing no evidence of contact

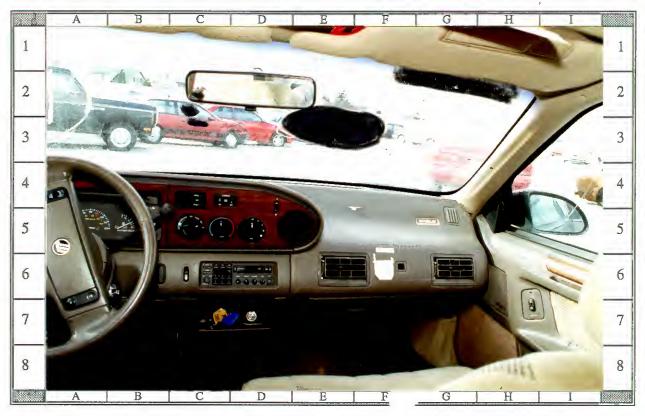
73 -- Vehicle #2's center and right dash, windshield, rear view mirror, and right A-pillar viewed from rear center position showing no evidence of contact

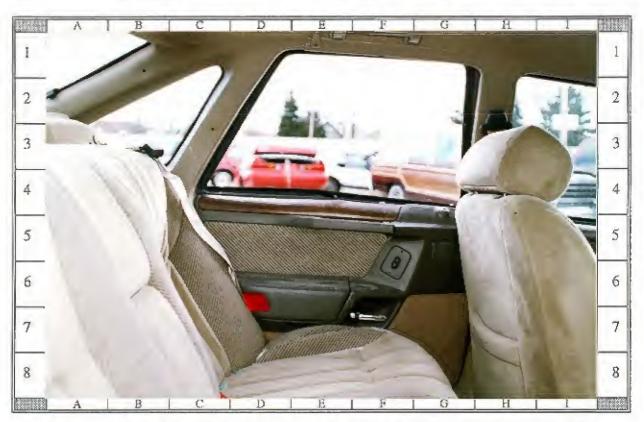
75 -- Vehicle #2's left rear door showing intrusion from impact with Case Vehicle; NOTE: adjustable front head restraints and fixed B-pillar anchorages

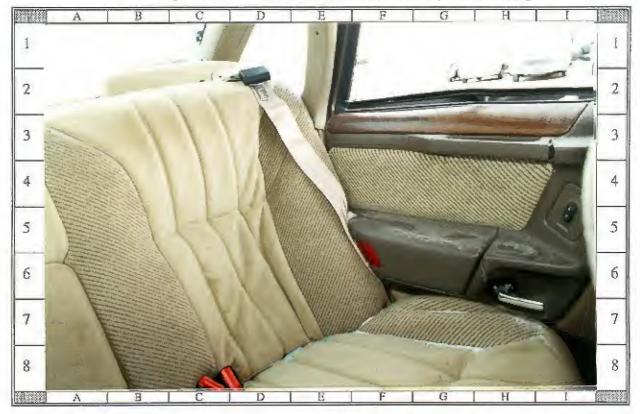
76 -- Vehicle #2's left rear seating area showing seat intrusion from left rear door; NOTE: fixed rear head restraints and 3-point belts at outboard positions
